URBAN FORESTRY ASSOCIATES, INC.

ARBORIST REPORT

104 Calumet Avenue, San Anselmo, 94960

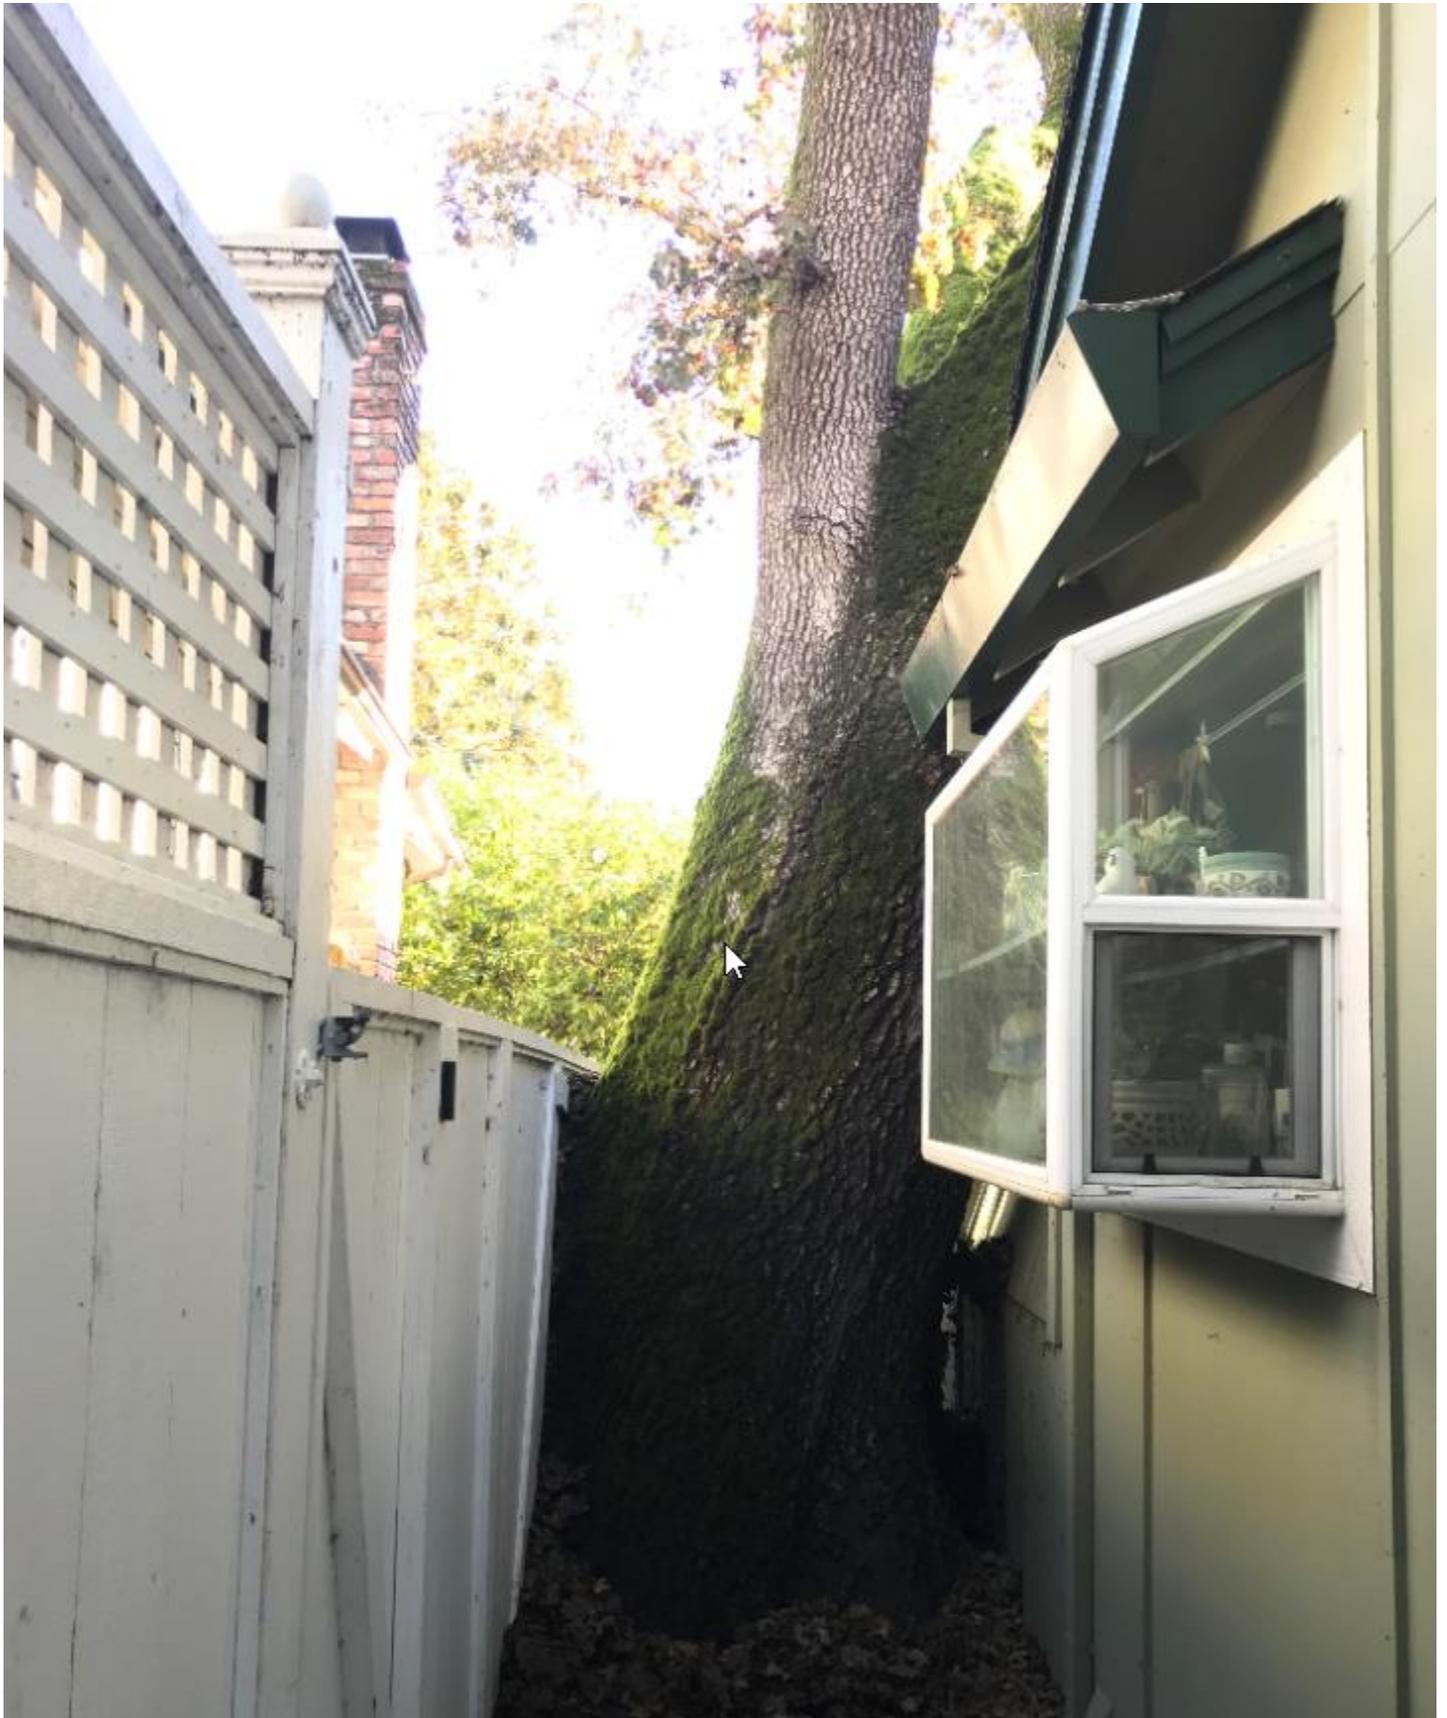
Species	<i>Quercus lobata</i> (valley oak)
Size	Two stems; 40, 16 DBH ¹ The diameter was visually estimated due to poor access between the house and fence, though it qualifies as "Heritage" pursuant to San Anselmo Municipal Code.
Location	Figure 1. The tree stands (approximately 60-feet tall) in the side yard(s) between 100 and 104 Calumet Avenue, though most of the trunk and canopy are distributed toward 100 Calumet Ave. Respectively, the main trunk and subordinate trunks are directly contacting the cut-out in the roof and roof line. The lower main trunk is directly contacting the siding and foundation of the Nisja home (Figures 2-4) The main trunk is within approximately 3 feet of the siding for the home at 100 Calumet Ave.

Figure 2. Nisja home (right). Note main trunk directly contacting siding/ foundation.

Recom'd Whole tree removal to abate the risk.

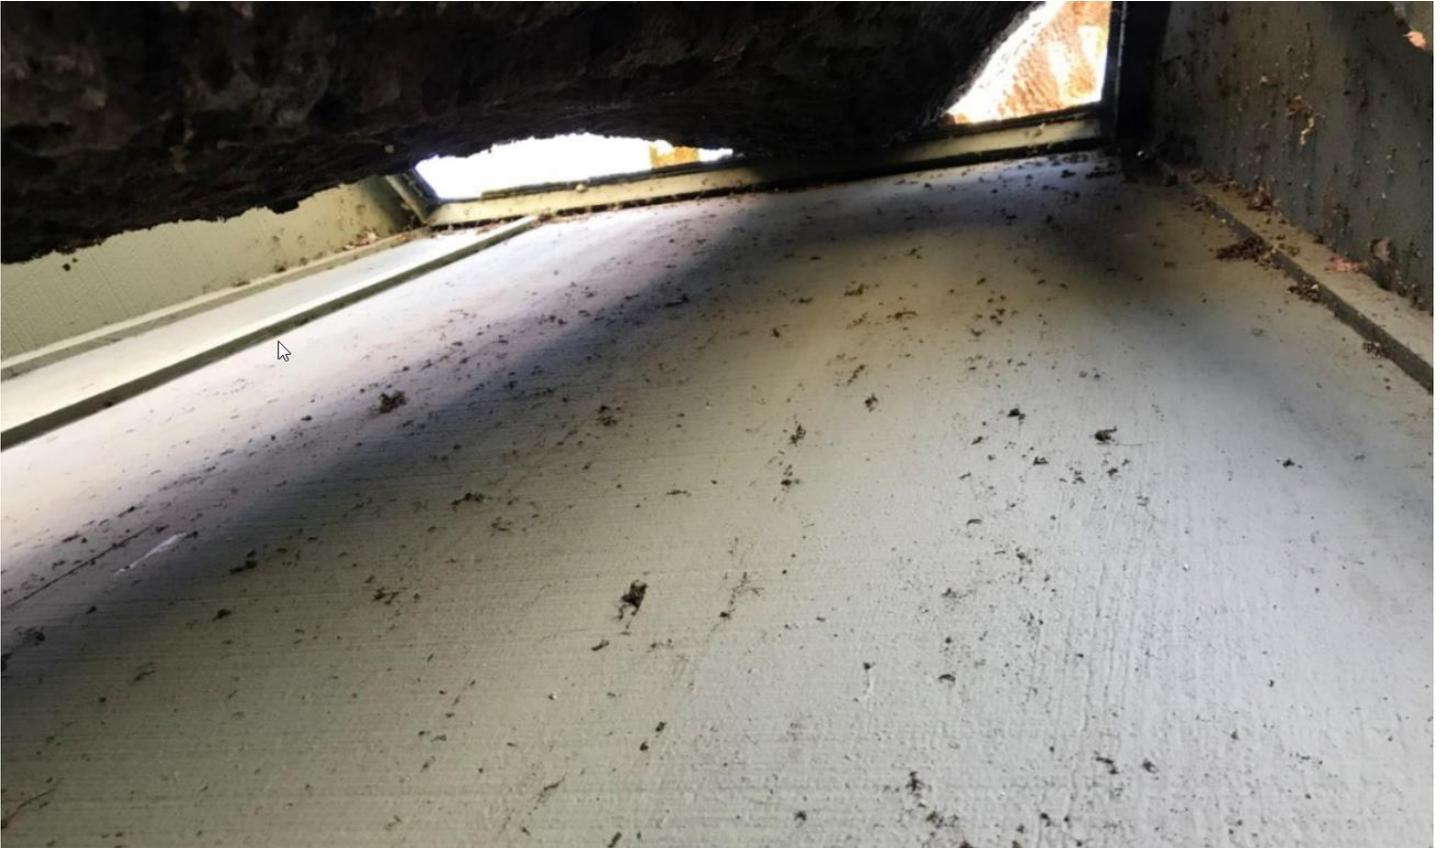
Conclusion Unfortunately the subject tree has outgrown the available space near the Nisja home and is posing risk of structural damage to the roof, siding and foundation.

Figure 3. Photo taken from Nisja side yard looking up at the main trunk contacting roof.

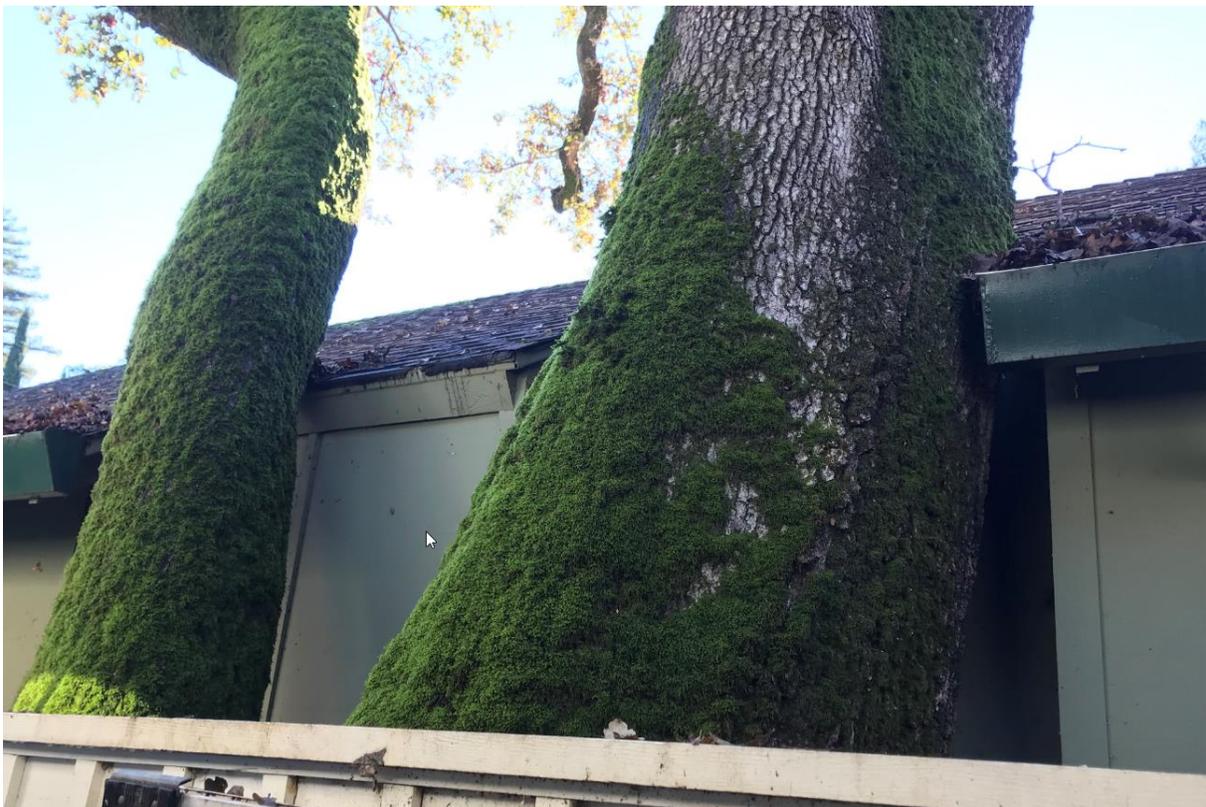
Figure 4. View of both trunks against Nisja roof. Phot taken from 100 Calumet Ave. side yard.

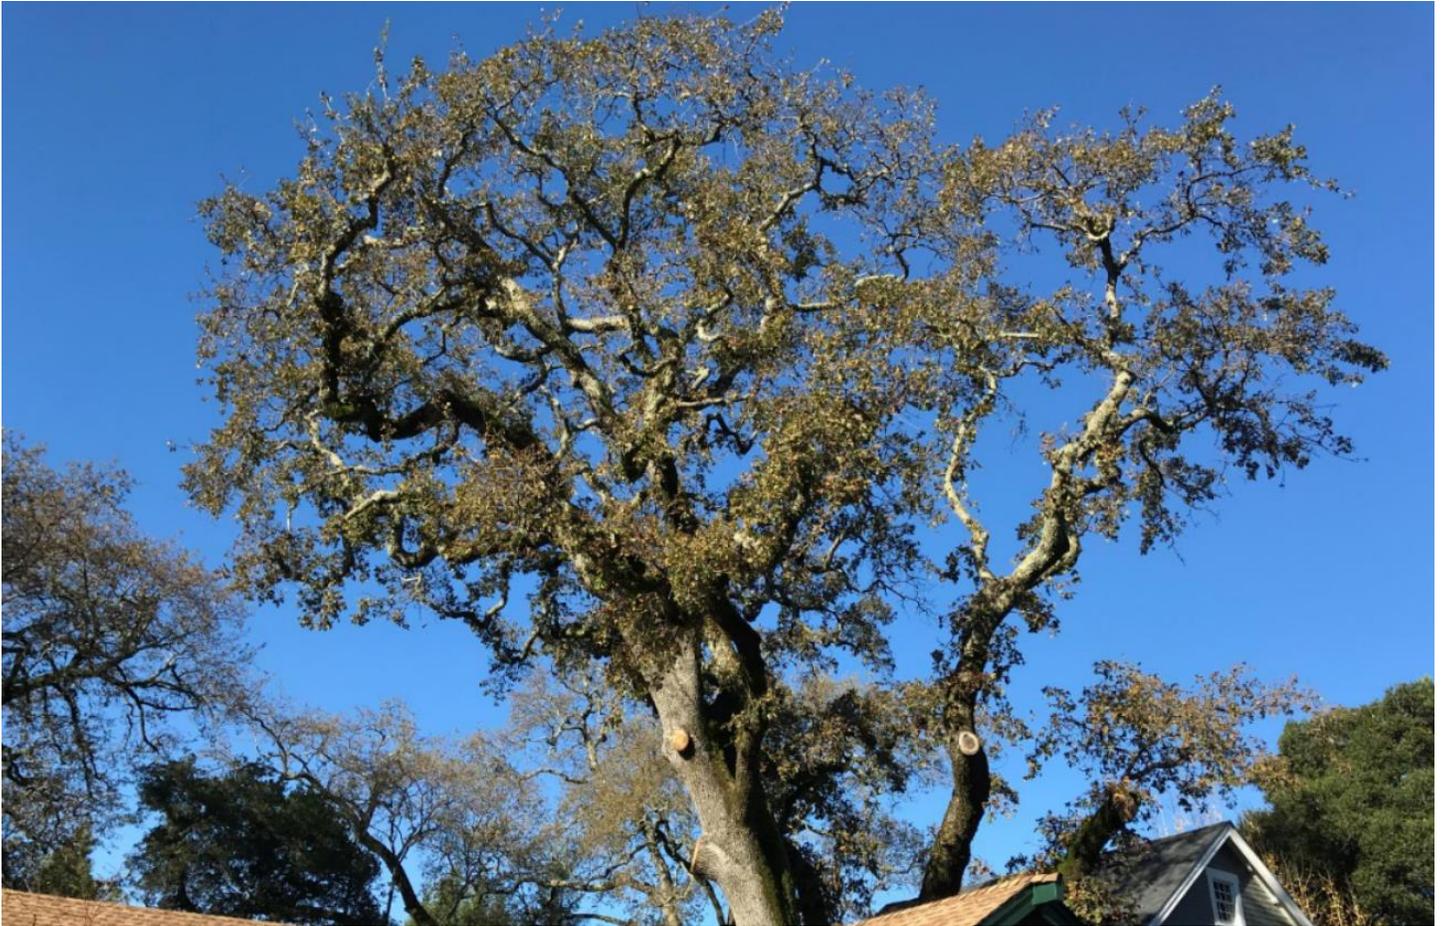
Condition Relative to its trunk diameter the canopy is compact, in part due to the history of pruning, and recent pruning, resulting in significant unweighting of the south canopy quadrant.

Figure 5. Subject tree's canopy
