ARBORIST REPORT

**Assessment of Two Coast Live Oaks
93 Hillside Avenue and 340 Laurel Avenue
San Anselmo, California
(APN: 007-121-28 & 57)**

Prepared by:
**Dr. Kent Julin
ISA Certified Arborist
California Professional Forester
ARBORSCIENCE, LLC**

March 30, 2019

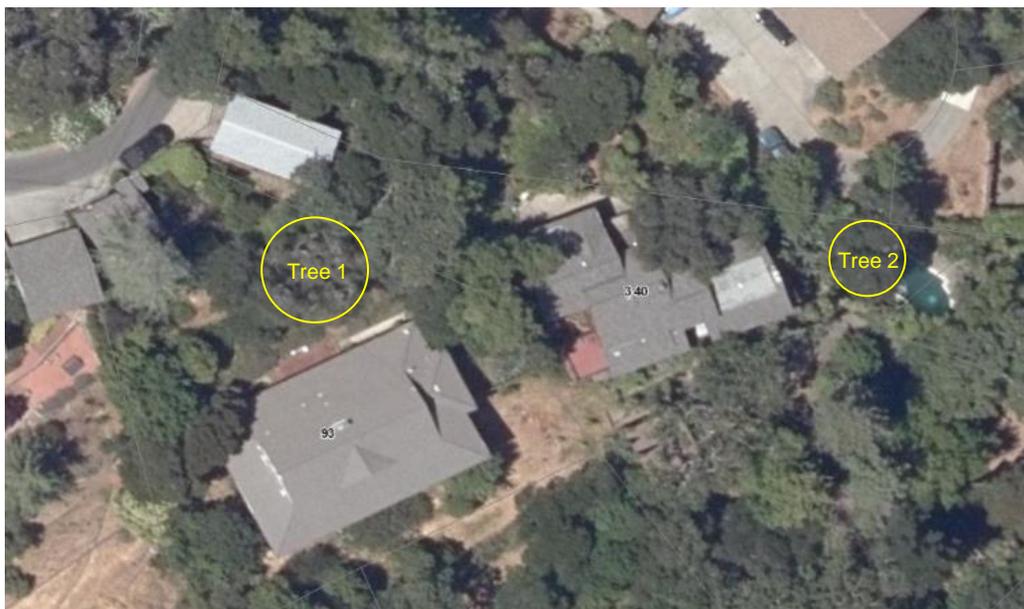
The homes at 93 Hillside Avenue and 340 Laurel Avenue were built in 1900 and 1913, respectively on a moderately steep, south-facing, wooded slope. Tree 1 is north of the house at 93 Hillside Avenue and Tree 2 is northwest of the pool at 340 Laurel Avenue (see photo below).
