**REPORT DATE:** May 20, 2019

***SERVICE: ARBORIST INSPECTION OF PALM TREE***

**INSPECTION LOCATION:** 1035 Sir Francis Drake Blvd., San Anselmo, California

**SUBJECT TREE No. 1: Canary Island Date Palm (*Phoenix canariensis*)**

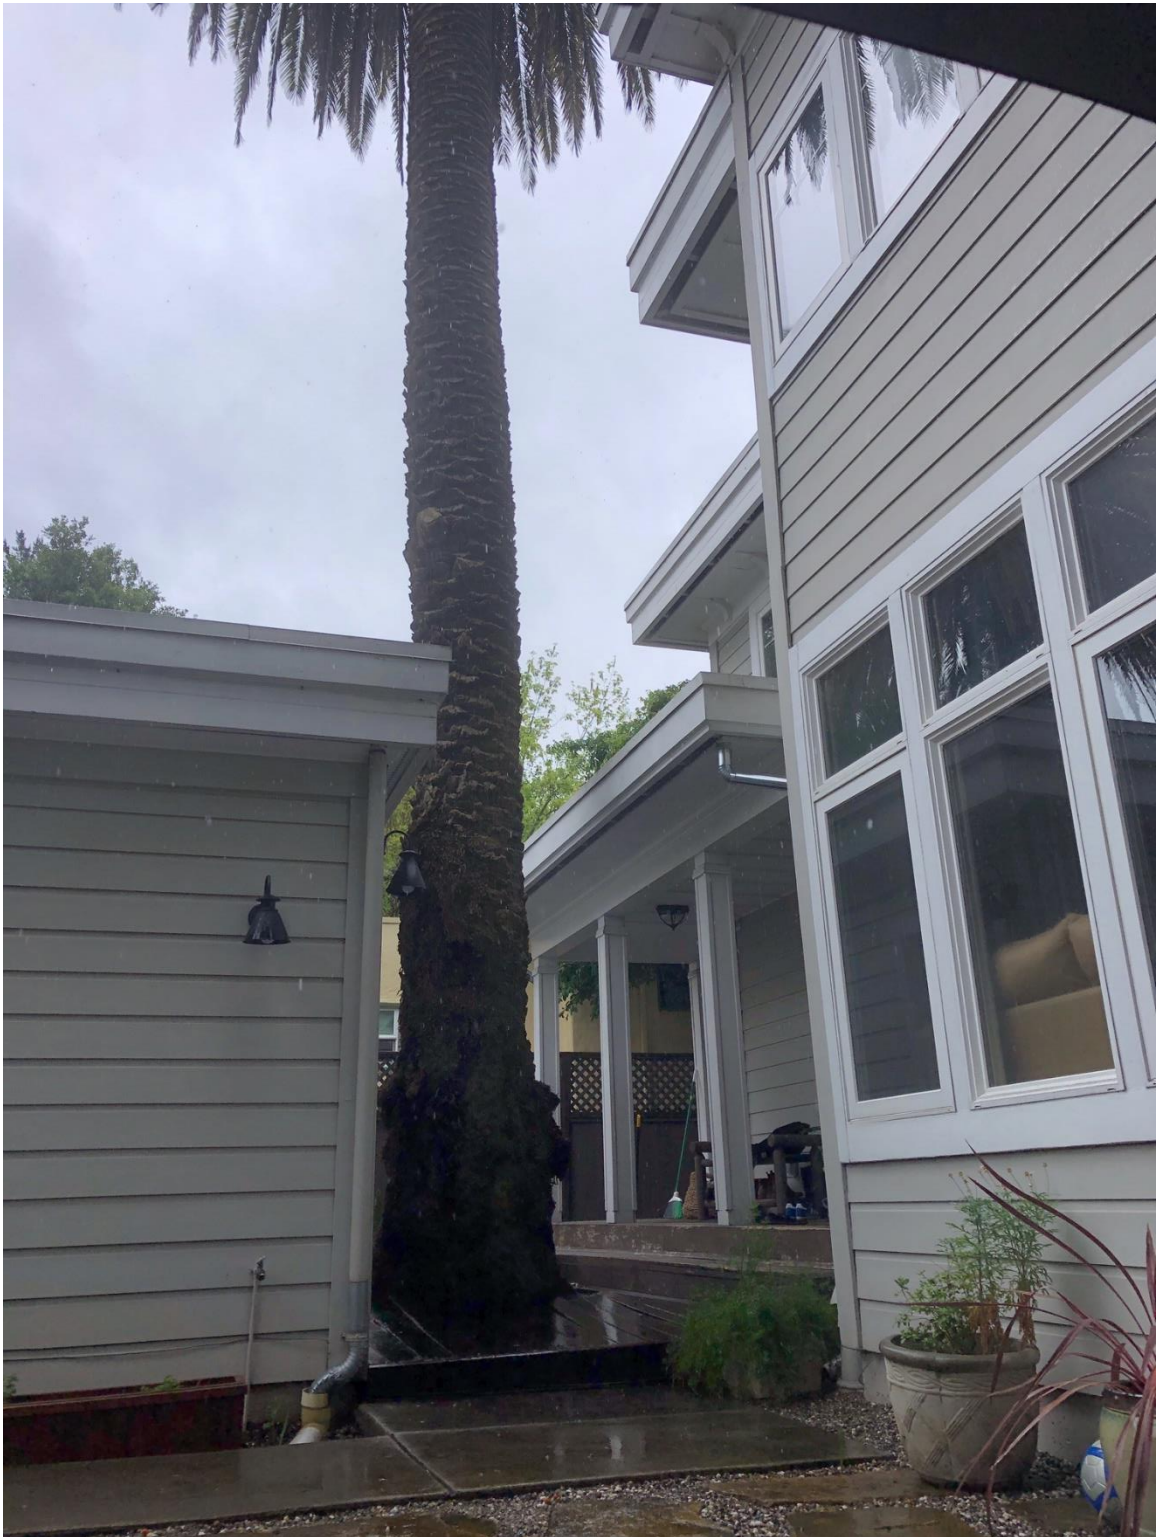
**CONDITION:** Poor; this tree is located in direct proximity of garage foundation and close to the house. It has grown tall enough that there is high likelihood of damage to the garage and house roof overhangs and gutters during high wind events.

**PHOTOGRAPH 1** - Subject tree showing its trunk location between garage and house.

**RECOMMENDATIONS:** Removal of this tree. The stump may be ground for future planting but will not re-sprout from its stump.

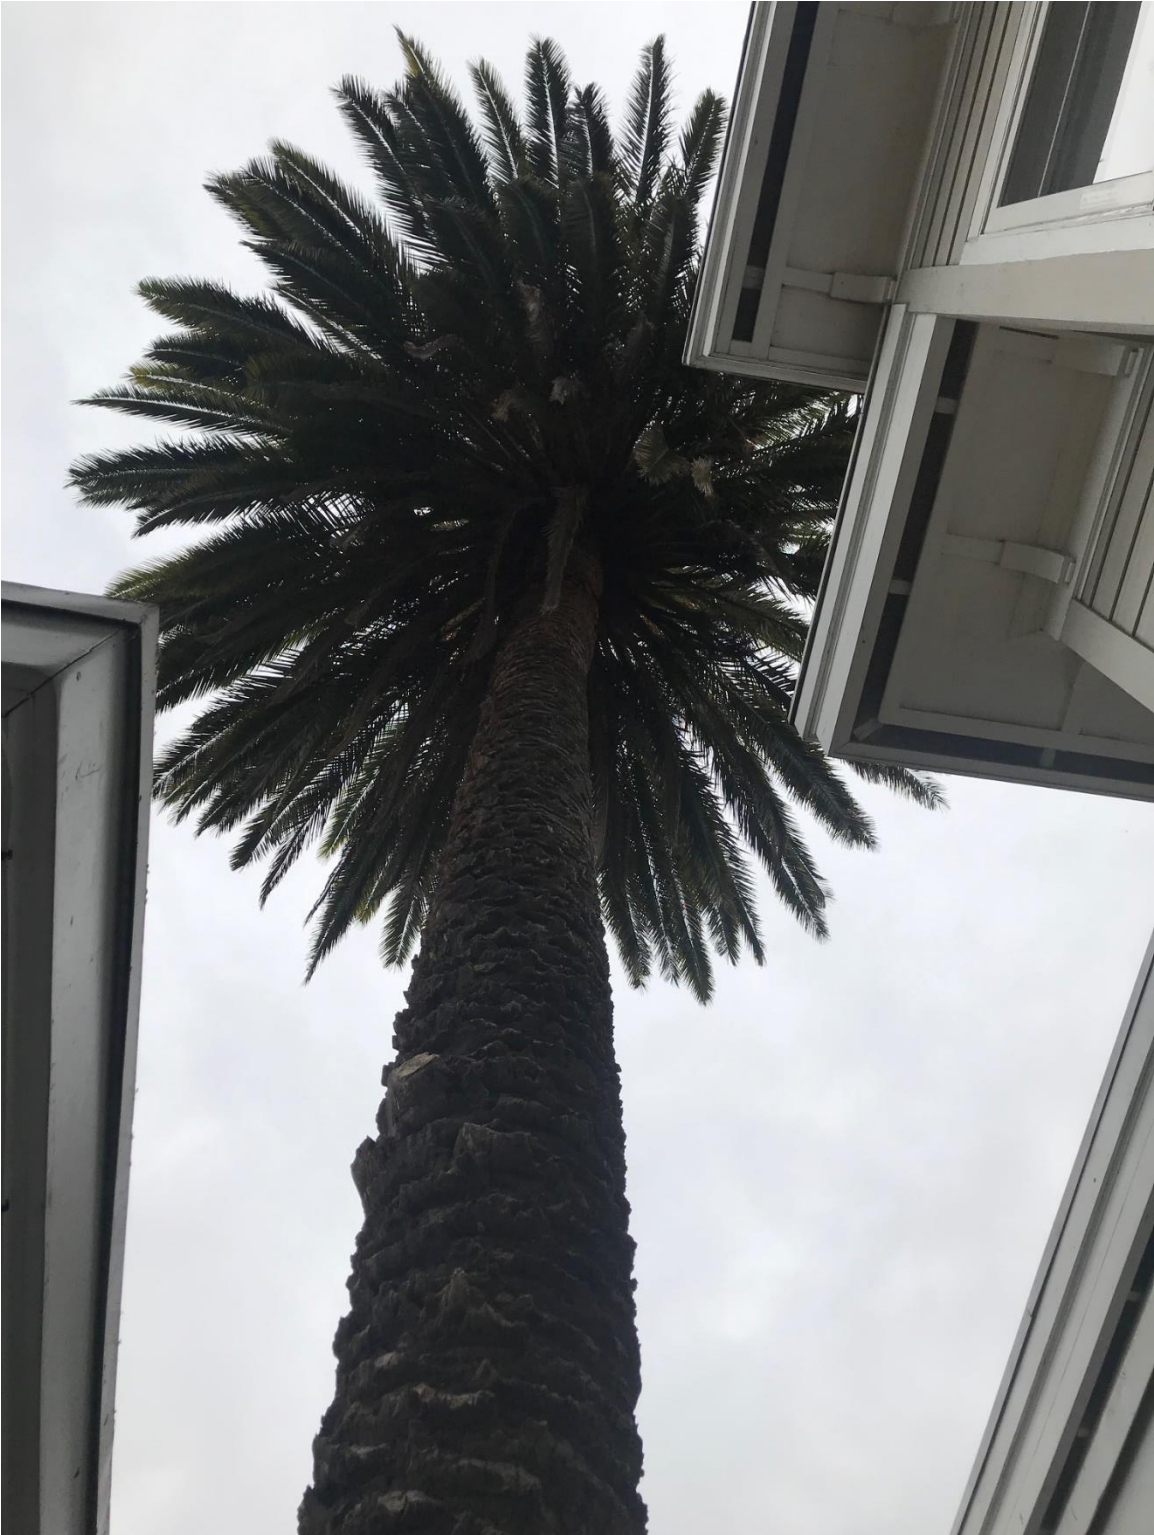
**PHOTOGRAPH 2** - Subject tree showing its trunk location between garage and house.

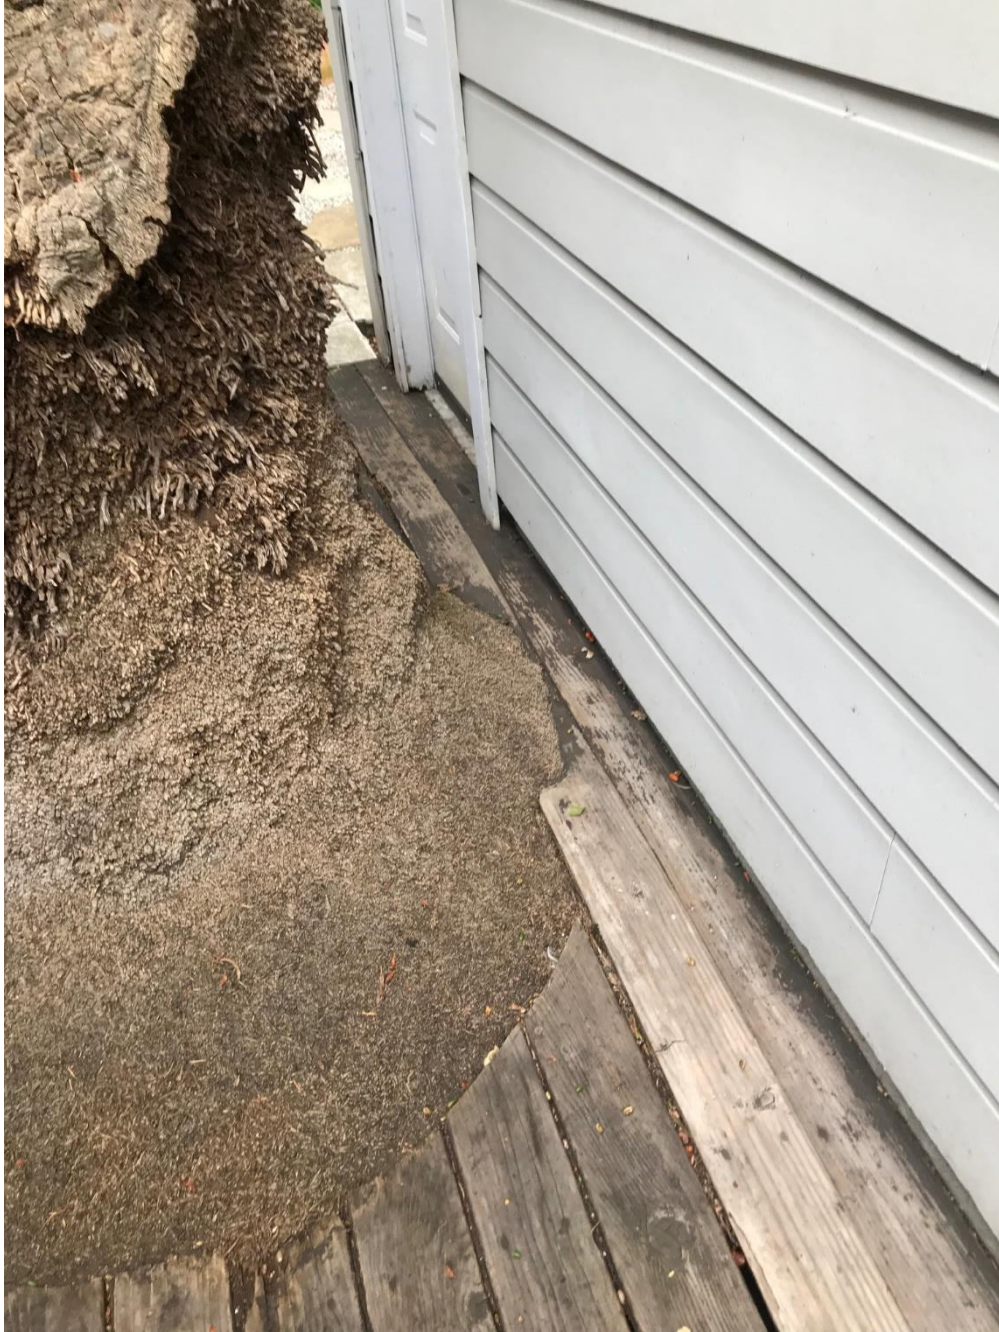
**DISCUSSION:** The subject is a mature non-native tree in good health. This species can cause foundation damage when in very close proximity of a house or garage structural foundation. As this is a mature tree, it is not likely to grow much larger and if damage were to occur to the garage foundation it would be present now and not likely to cause more damage. It should be noted that ArborLogic was not able to observe foundation damage at the time of the inspection. This species is known for excessive movement during high wind events.

**PHOTOGRAPH 3** - Subject tree showing its trunk location in direct proximity to garage foundation.
