Project Address: 27 Bella Vista Ave., San Anselmo

Inspection Date: October 23, 2019

Assignment

Tree 1

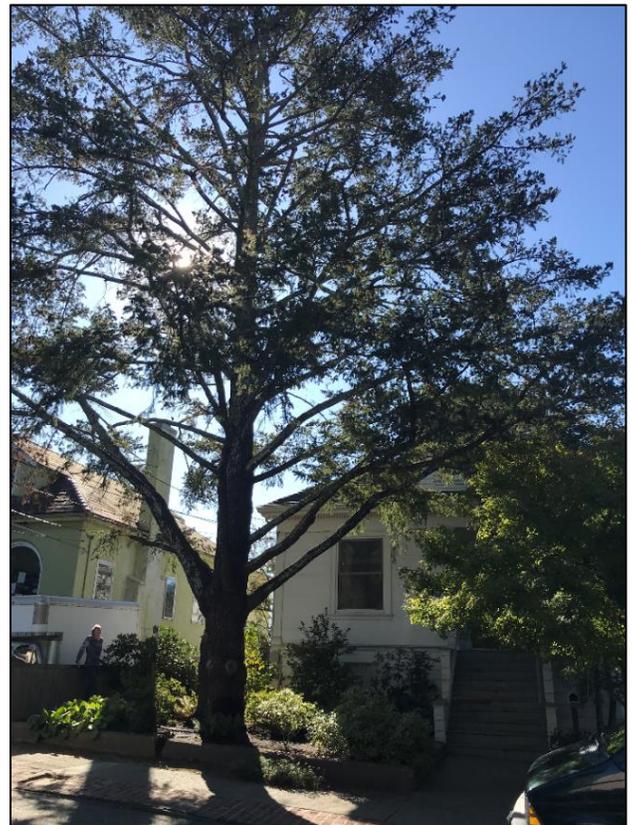
Location The tree stands in the front yard of 27 Bella Vista Avenue in a compact planter. The trunk is approximately 4 feet from the sidewalk and 12 feet from the home. The canopy extends over the roof. The tree reportedly stands within 5 feet of a recently replaced sewer line (See Figure 1,3).

Figure 1. Subject tree as viewed from the street.

Whole tree removal.

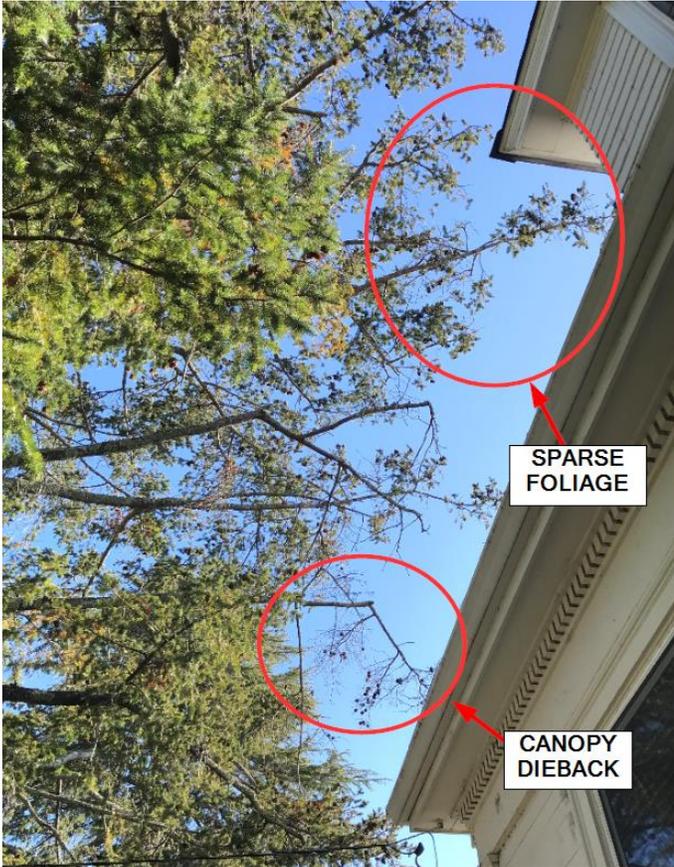
Figure 3. The canopy as viewed from the entry walkway of 27 Bella Vista Ave. Note how sparse the canopy appears.

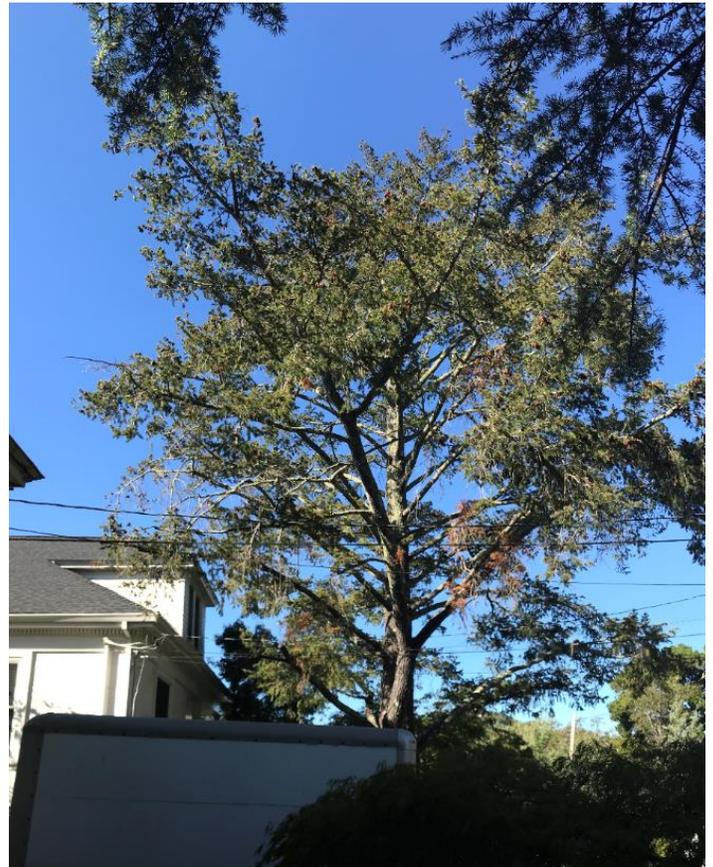
Health- Fair. The canopy is sparsely foliated and exhibits dieback in the canopy over the home (See Figure 2).

There was no clear indication of why the canopy is sparse although it is possible that the trenching performed during sewer line replacement damaged roots. Regardless, the tree is placed in a suboptimal area near utilities and hardscape and is a fire prone species standing within the defensible space zone of the home. Per Firesafemarin.org [Fir trees](#) are not recommended for planting within the defensible space zone of homes.

Figure 2. The canopy as viewed from the front yard of 25 Bella Vista Ave.
