Client: Lou Dangles
Project Location: 74 Madrone Avenue, San Anselmo
Inspection Date: October 17, 2019
Arborist: Ben Anderson

URBAN FORESTRY ASSOCIATES, INC.

Assignment

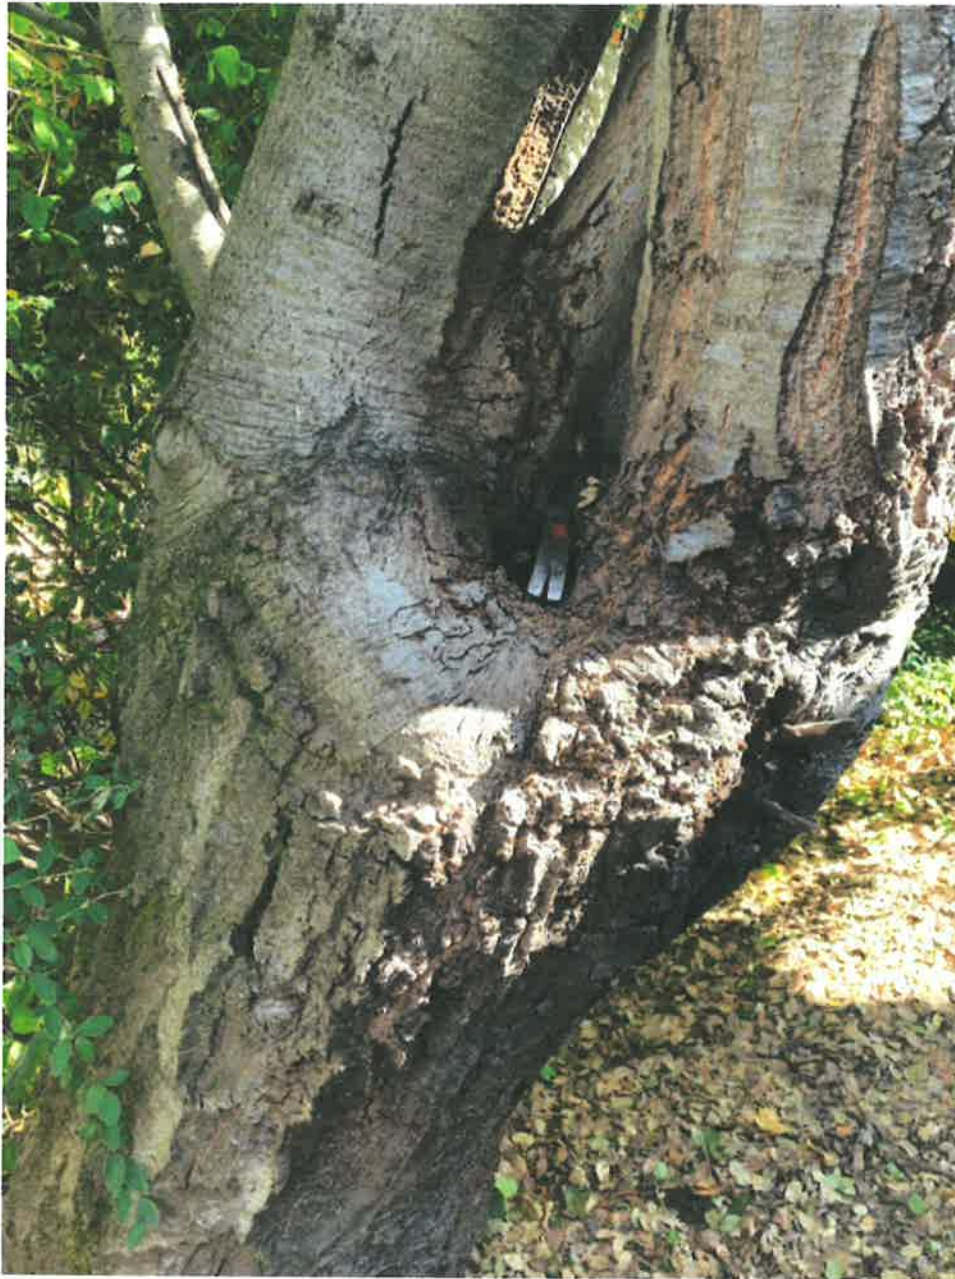
Poorly attached codominant stems are a common structural defect with an elevated likelihood of failure. The decay cavity in the attachment further elevates this likelihood. This has been a particularly bad year for cryptocline in the Bay Area. This is a native fungal pathogen that affects the leaves and twigs of a tree but does not typically have any long-term effects on the health of the tree.

Figure 2. Decay cavity in the common attachment of the codominant spars. Framing hammer inserted in the cavity visible in the center of the image.

Likelihood of failure could be mitigated through pruning and/or cabling, but this would not solve the inherent structural issue in the tree. Removal of individual spars posing the most danger to targets would leave too large a wound at the common attachment of any remaining spars. These wounds would then decay, further elevating the likelihood of failure.

Due to the structural issues and poor location of the tree, whole-tree removal is a reasonable management option.

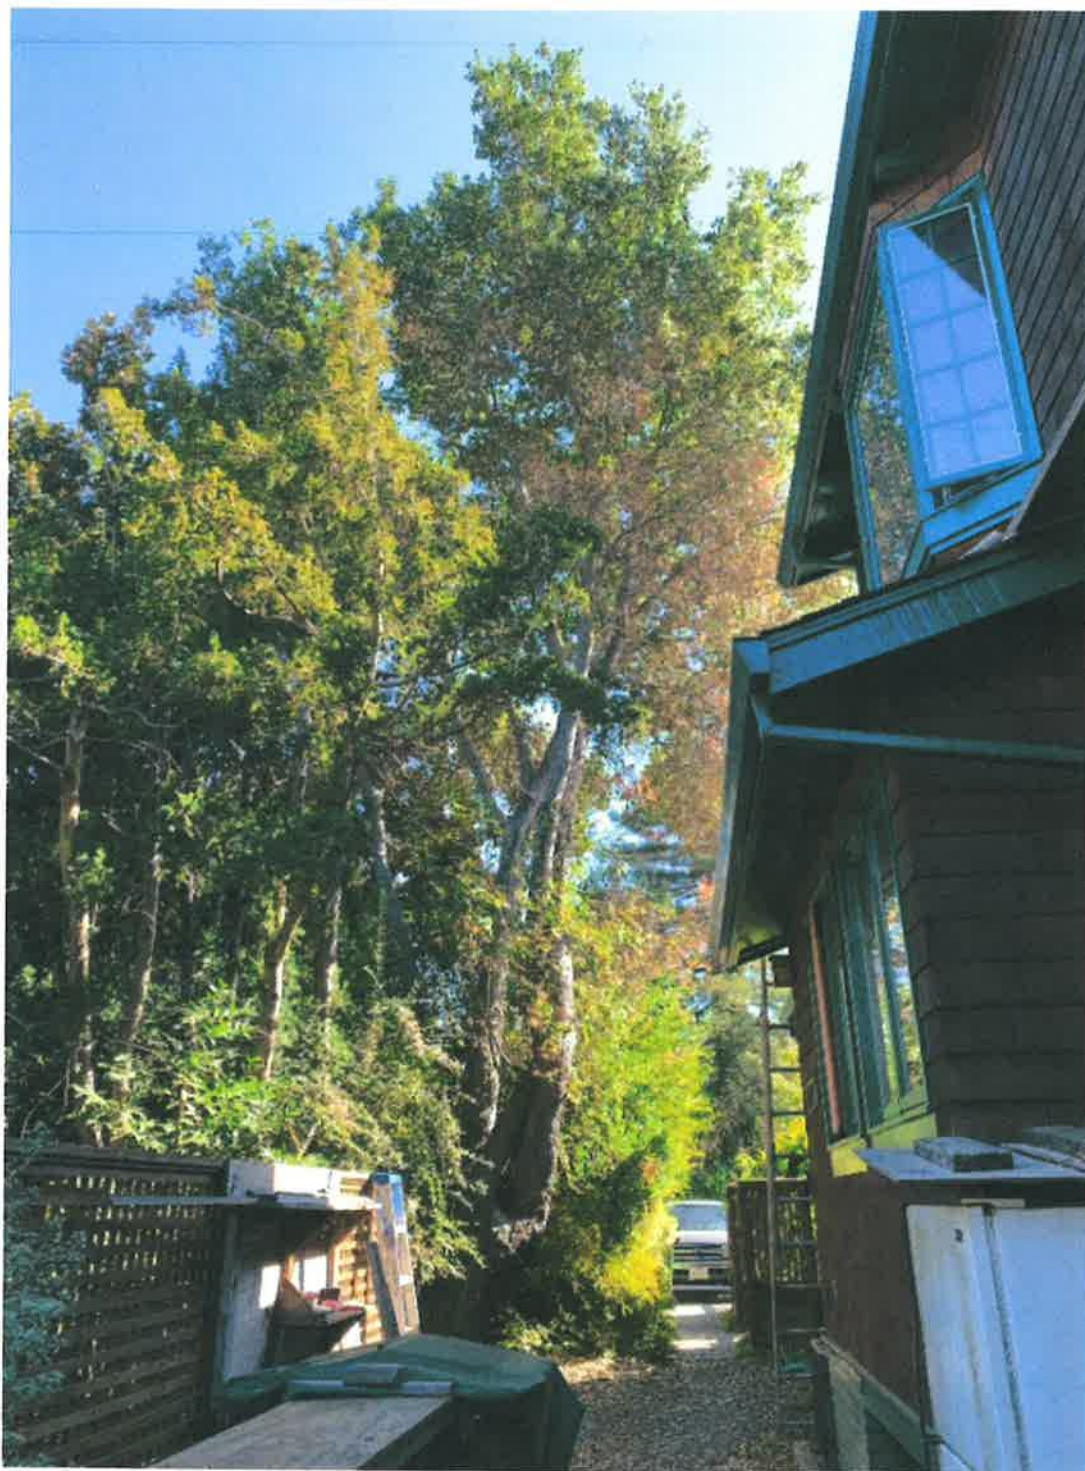
Figure 3. Subject tree as viewed from the north looking south.
