SUPPLEMENTAL QUESTIONNAIRE FOR TREE WORK PERMIT

Project Address: 19 Myrtle Lane, San Anselmo

Inspection Date: November 16, 2020

ASSIGNMENT/ BACKGROUND

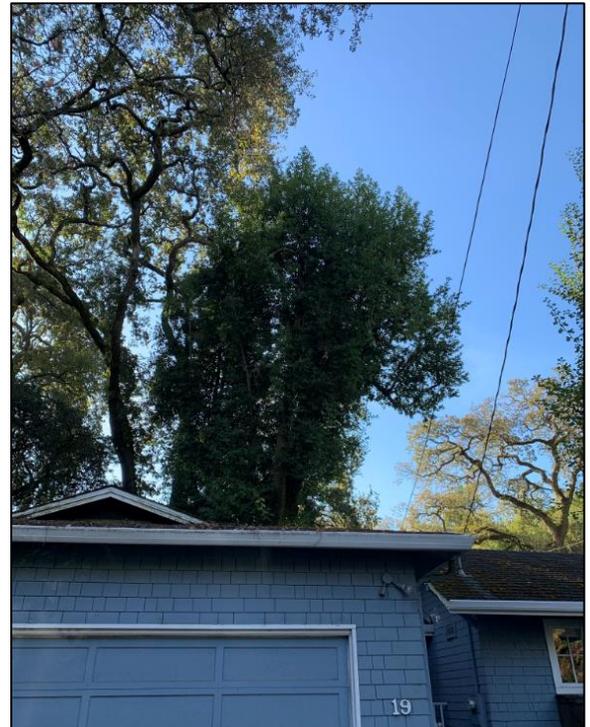
The subject tree is mature and was once a large specimen, however, in the distant past the tree was pruned aggressively (topped) to a height of approximately forty feet. The canopy is composed of vertical stems from which small diameter sprouts have grown creating an unnatural/bushy appearance (See Figure 1).

Figure 1. Subject tree as viewed from the Myrtle Lane

Whole tree removal.

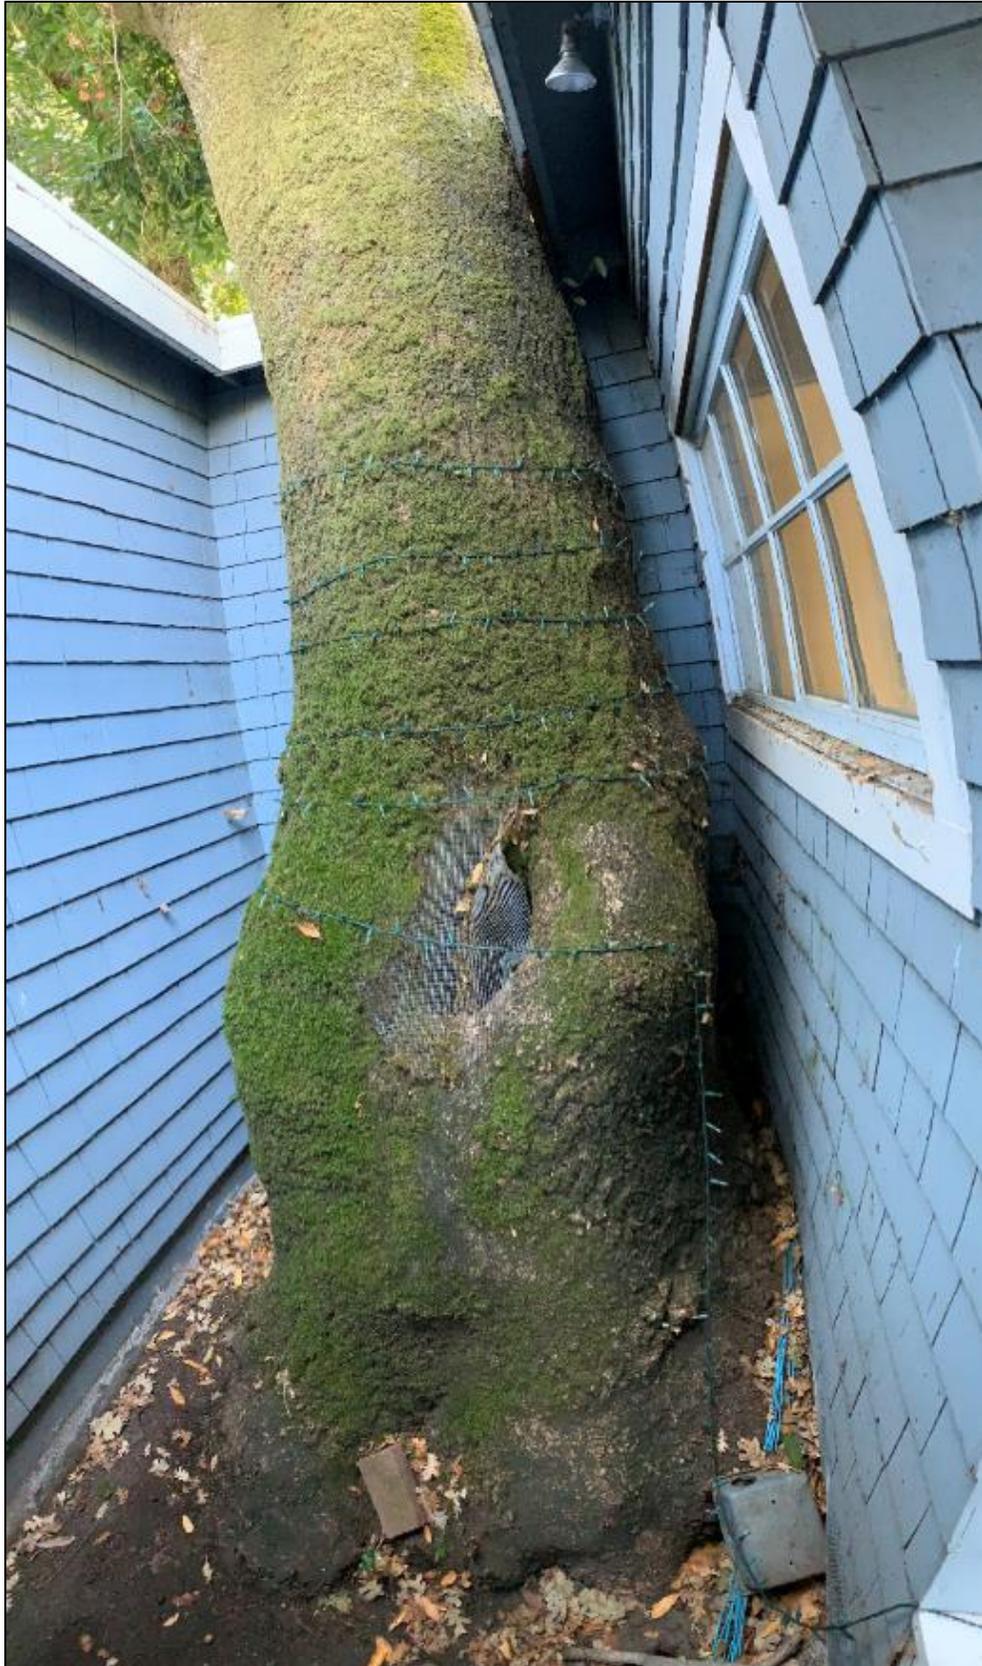
Location The house was built around the tree which stands in a rectangular cut-out in the home between the garage and front entryway. There is less than a foot of space between the lower trunk and home foundation. The trunk is conflicting with the roof (See Figures 2,3).

Figure 2. View of the tree relative to the home.

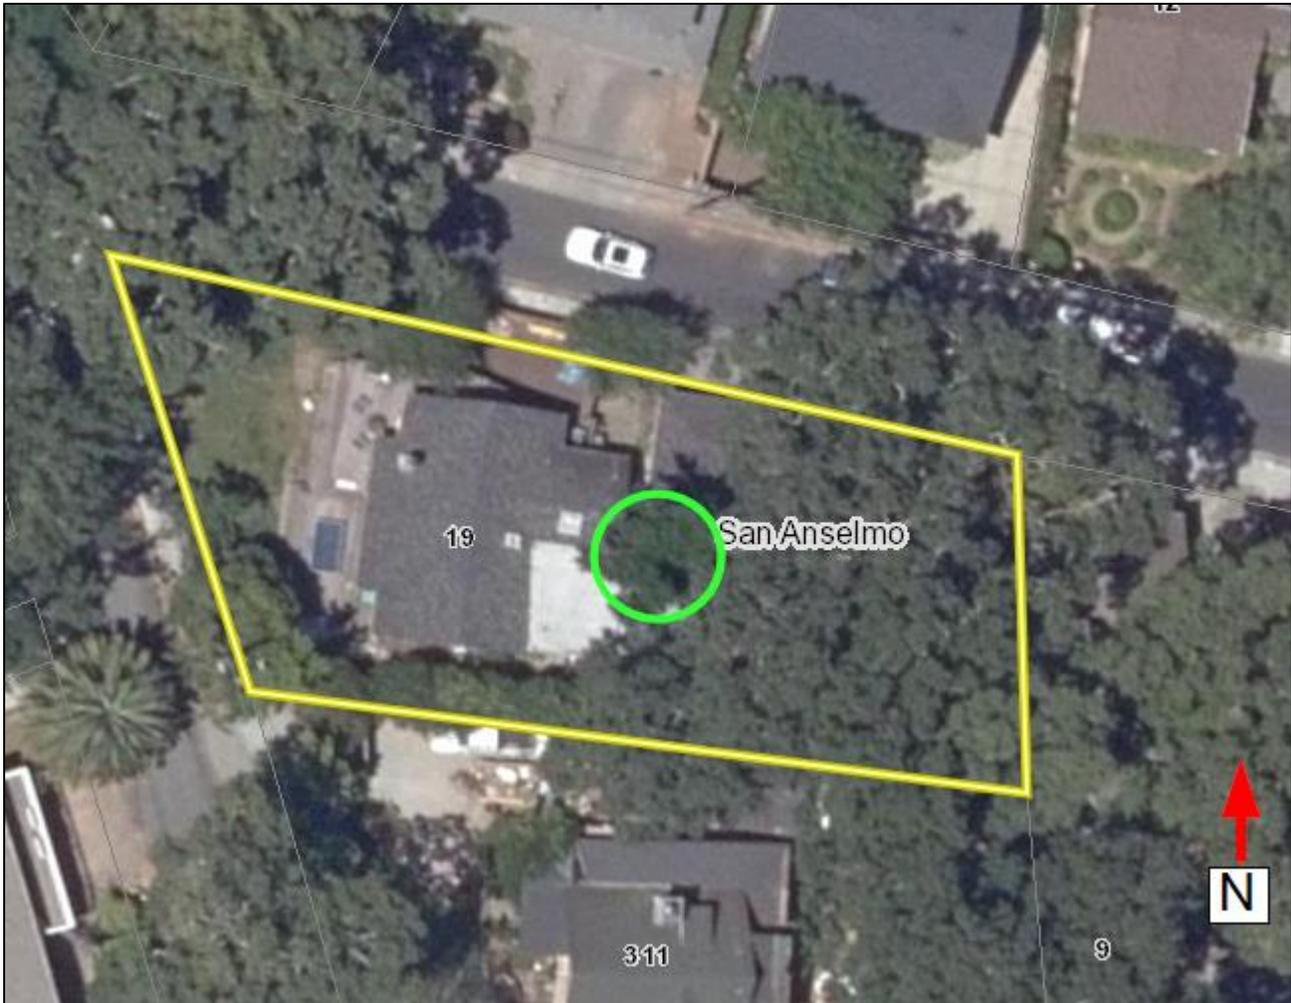
Figure 3. Site plan. Green circle indicates the approximate canopy outline.

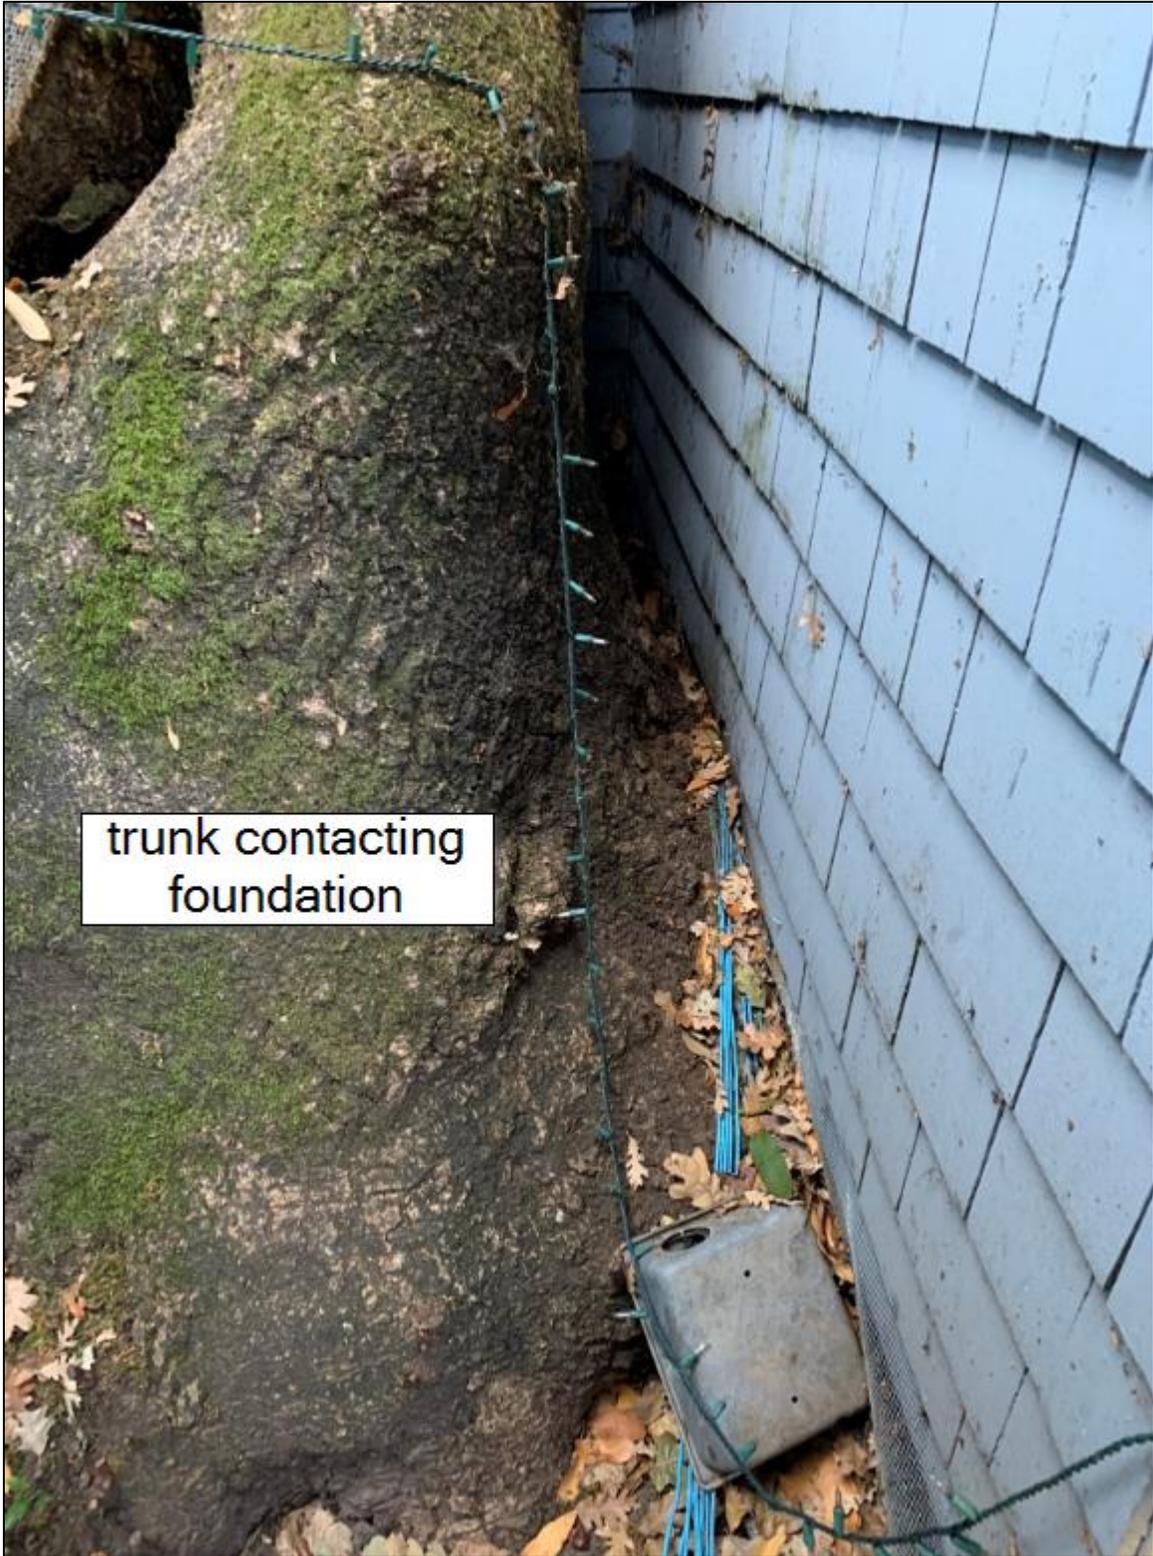
Most of the tree's root system is covered by the home and the home foundation and the trunk is conflicting with the roof. There is established **heartwood rot** in the trunk which extends up into the main trunk and down to grade.

Figure 4. View of lower trunk in relation to the foundation.
