Client: Lou Dangles
Project Location: 74 Madrone Avenue, San Anselmo
Inspection Date: October 17, 2019
Arborist: Ben Anderson

URBAN FORESTRY ASSOCIATES, INC.

Assignment

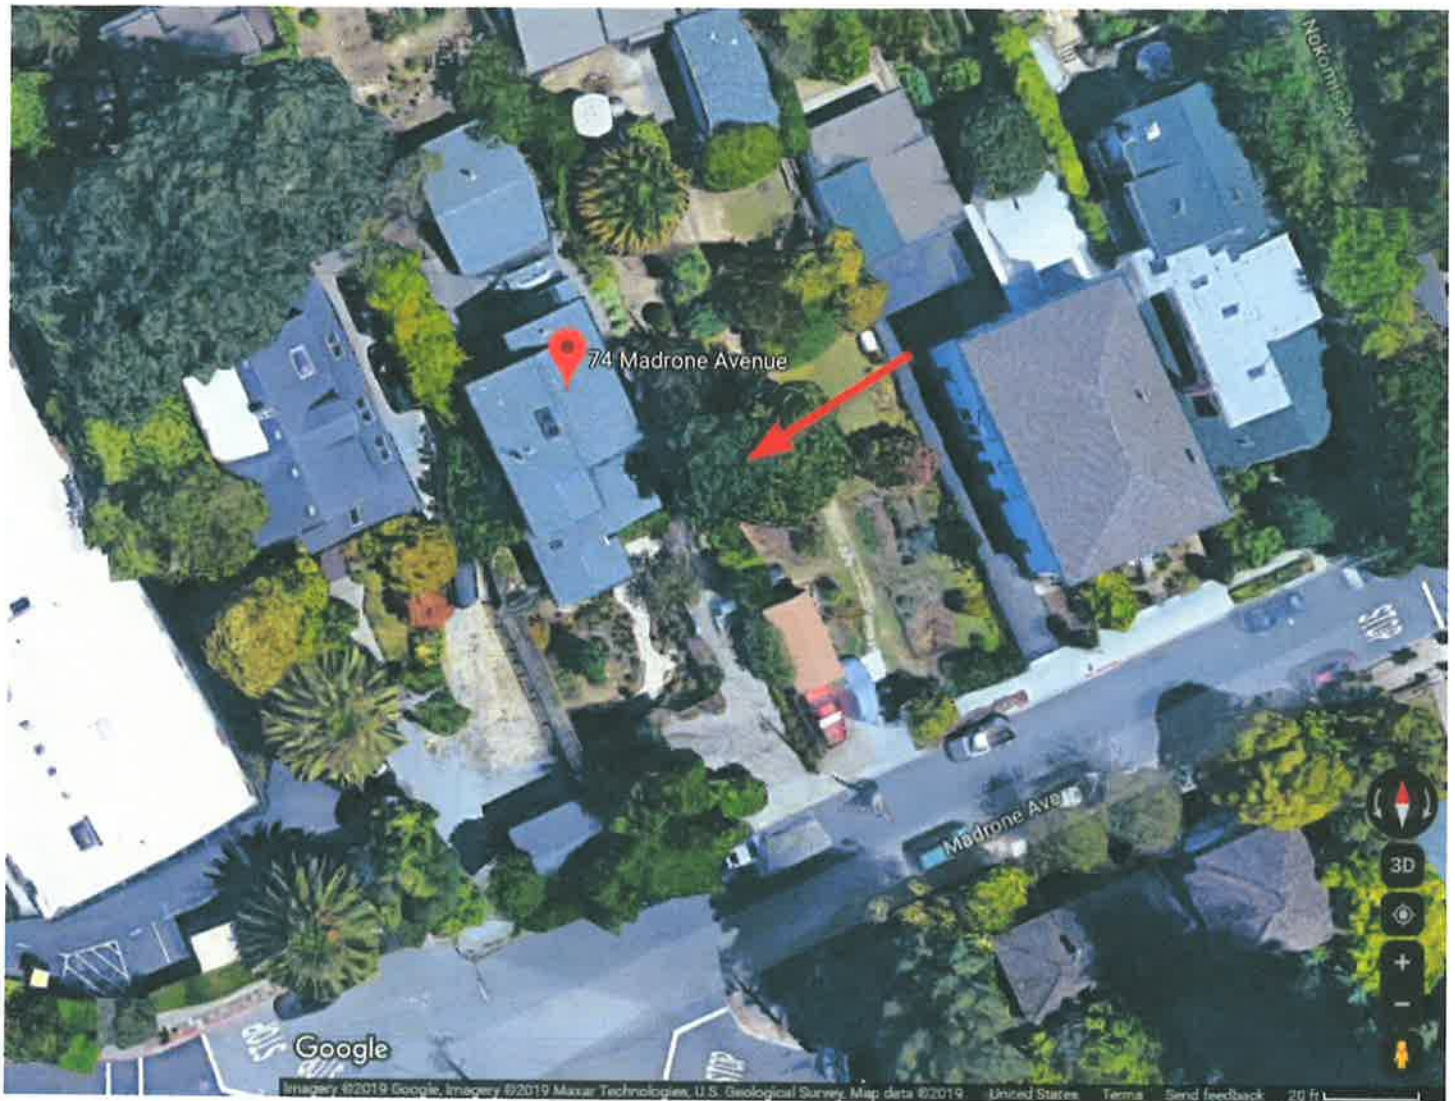
Species	coast live oak (<i>Quercus agrifolia</i>)
Diameter	24.0 inches
Location	Directly east of the home on the apparent property line with the east neighbor (Figure 1). The tree targets the Dangles home and the neighbor's secondary utility lines.
Health	Good. The canopy displays symptoms of cryptocline (<i>Cryptocline cinerescens</i>) in the form of scattered brown leaves in the lower canopy.
Structure ¹	Poor to fair. It appears the tree was topped at five feet above grade long ago. Six codominant stems ² arise from the topping cut. There is a decay cavity at the attachment (Figure 2). Two of these stems cross one another higher in the canopy, creating an additional structural weak point.
Form ³	Good. Upright with a high canopy (Figure 3).

Figure 1. Map of tree location. Approximate location of base indicated with red arrow.
